# Manhole Inspection Summary

Manhole # S17YY1021MH

Insp Date: **11/3/06 2:19 PM**

**Location** Address: **2010 GREENBERRY RD**

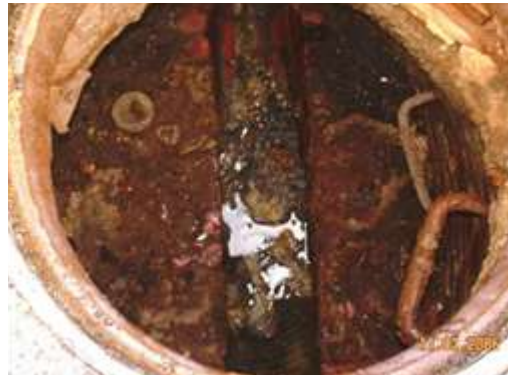
Top View

**Bench** ☒ Exists Material: **Brick** ☐ Parged ☒ **Debris** (not Condition related)

Condition: ☐ Sound ☐ Cracked ☐ Root Intrusion ☐ Deteriorated ☐ Leaks ☒ **Debris**

**Steps** Count: **2** Missing: **0** ☒ **Corroded**

**Surcharge** ☒ **Evidence Of Surcharge** Depth: **1** (ft.) ☐ Active Surcharge Present

Corroded steps. Evidence of surcharge - Bench debris. Channel debris.

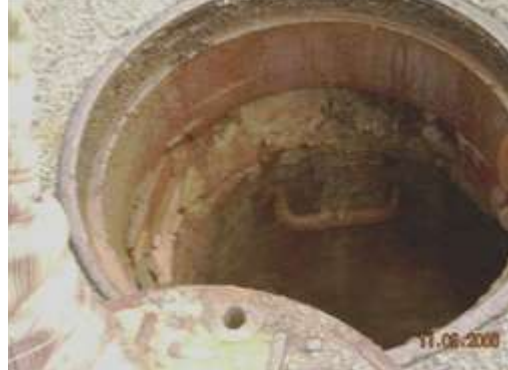
Defect

**Frame** Offset: **1** (in.) Condition: ☐ Sound ☐ Cracked ☒ **Leaks**

Condition: ☐ Sound ☒ **Cracked** ☐ Root Intrusion ☒ **Loose Brick** ☒ **Deteriorated**

Infiltration: ☐ None ☒ **Joint** ☒ **Cracks** ☒ **Mortar** ☐ Roots ☒ **Wall**

Frame offset. Adjustment cracks, loose brick, deterioration, and infiltration.

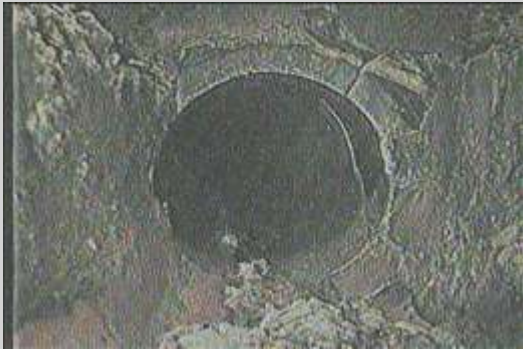
### 8 in. Circular Gravity Sewer Pipe Out @ 12 O'Clock

Deposits: ☐ None ☒ **Mud** ☐ Sludge ☒ **Debris** ☐ Grease

Infiltration: **Evidence** Pipe Seal Cond: **Cracked**

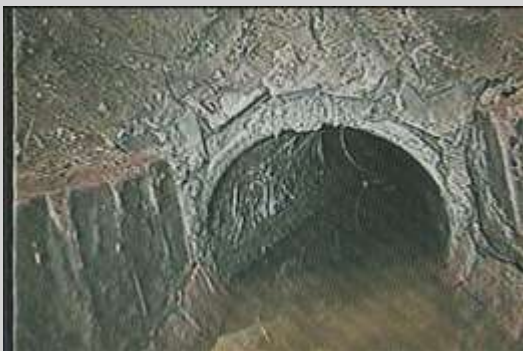
### 8 in. Circular Gravity Sewer Pipe In @ 6 O'Clock

Channel deterioration.

Deposits: ☐ None ☒ **Mud** ☐ Sludge ☒ **Debris** ☒ **Grease**
